REPORT OF MULTIPLE FATAL COAL OUTBURST ACCIDENT
NO. 2 MINE
UNITED STATES STEEL CORPORATION, COAL OPERATING DIVISION
GARY, McDOWELL COUNTY, WEST VIRGINIA

June 15, 1956

John Zeleskey
Federal Coal-Mine Inspector

Edward M. Lewis
Health and Safety Engineer

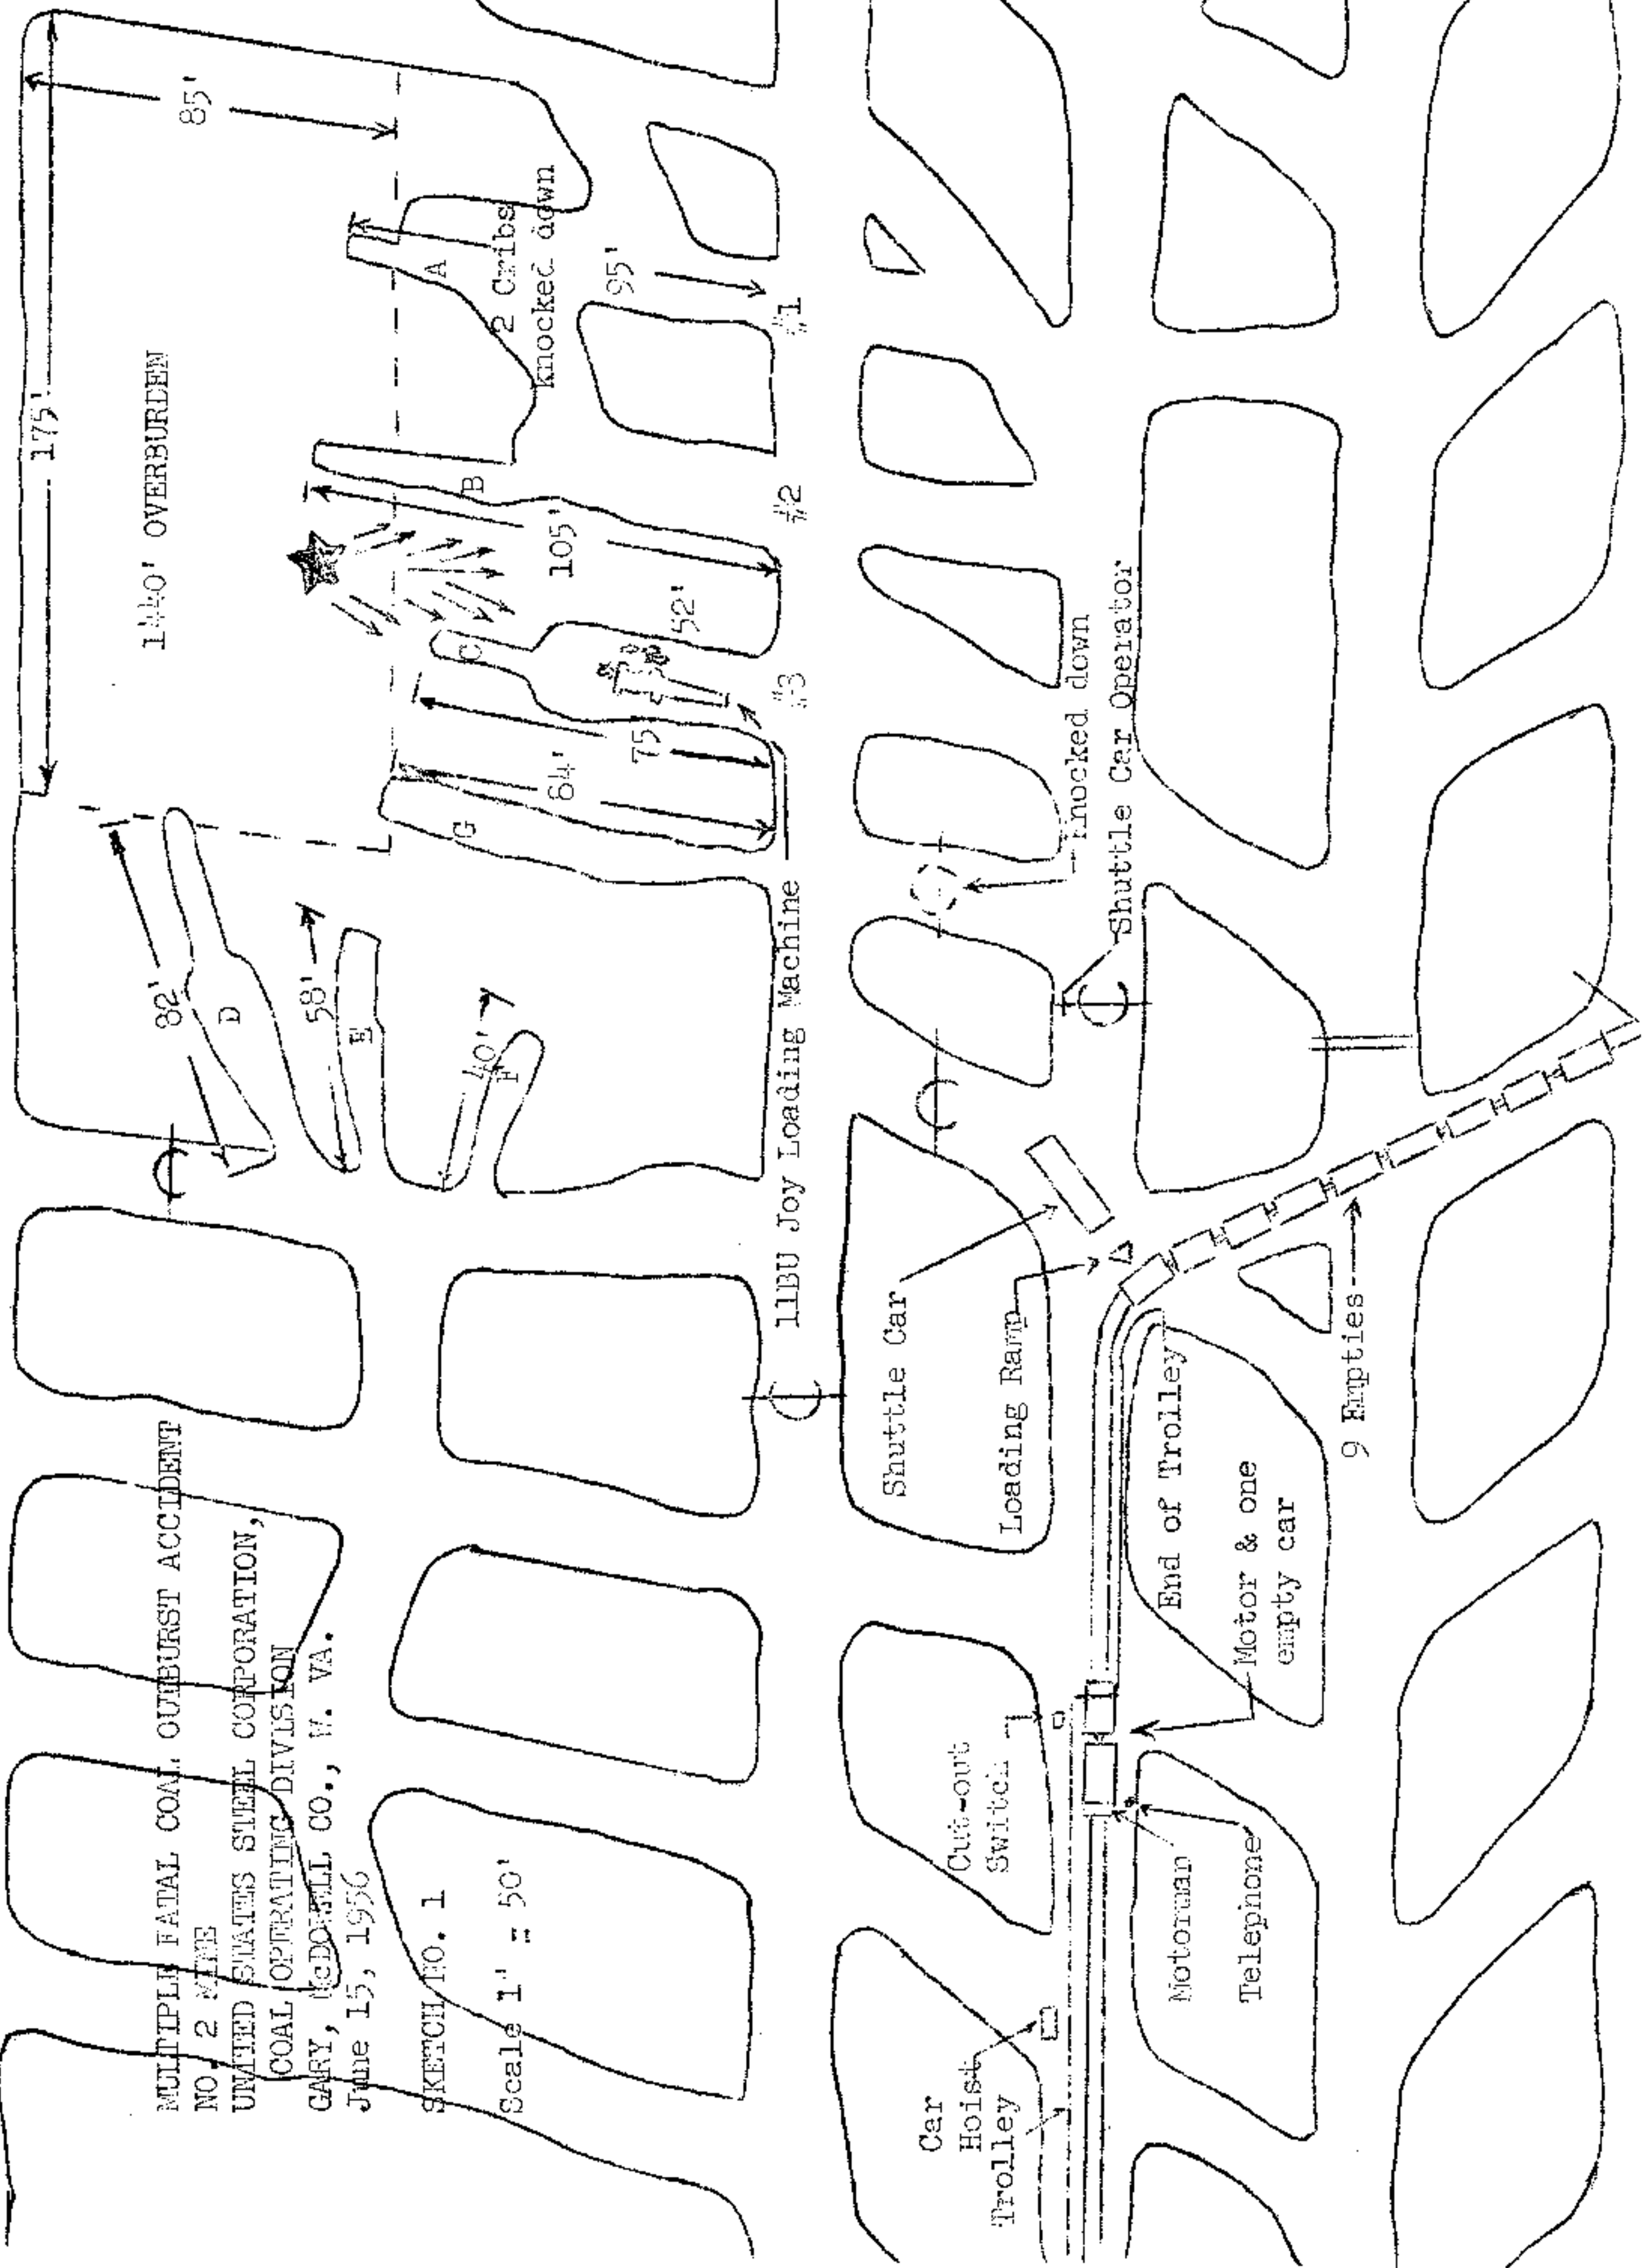
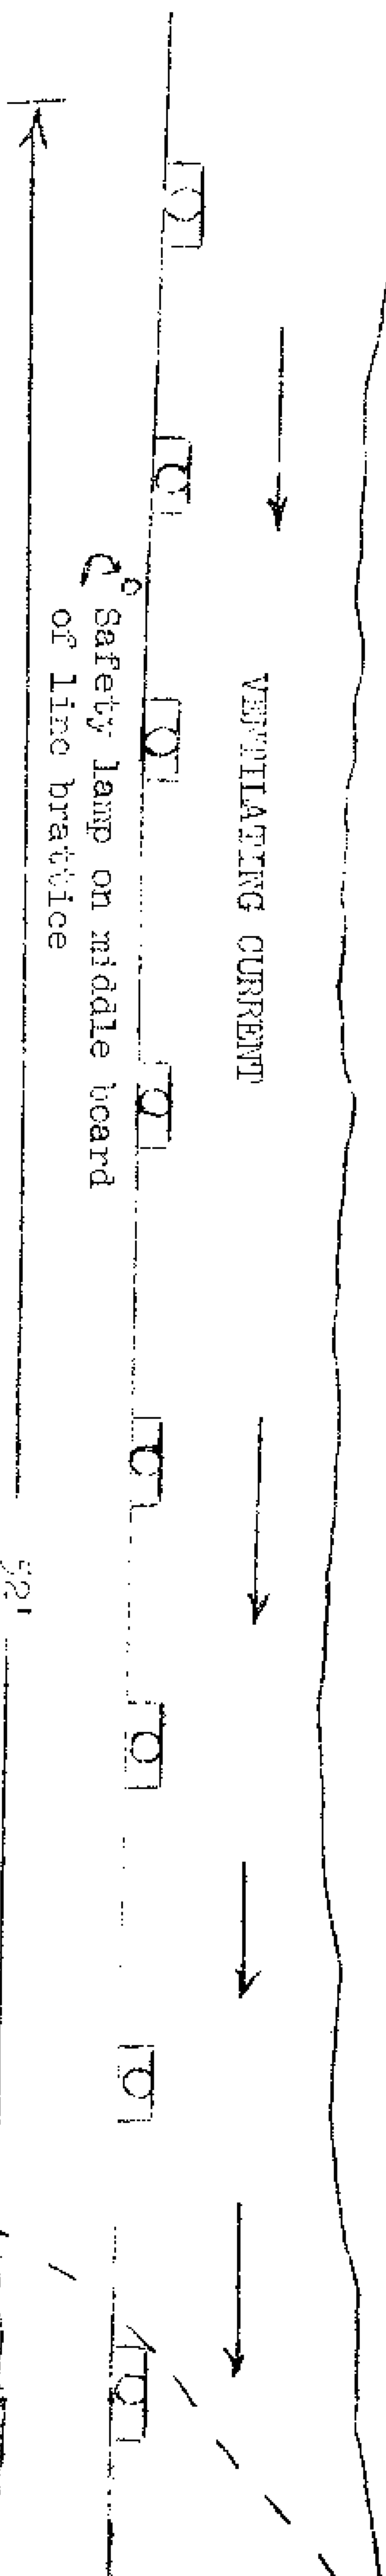
SKETCH NO. 1

No. 3
Room

Joy 11BU Loading Machine

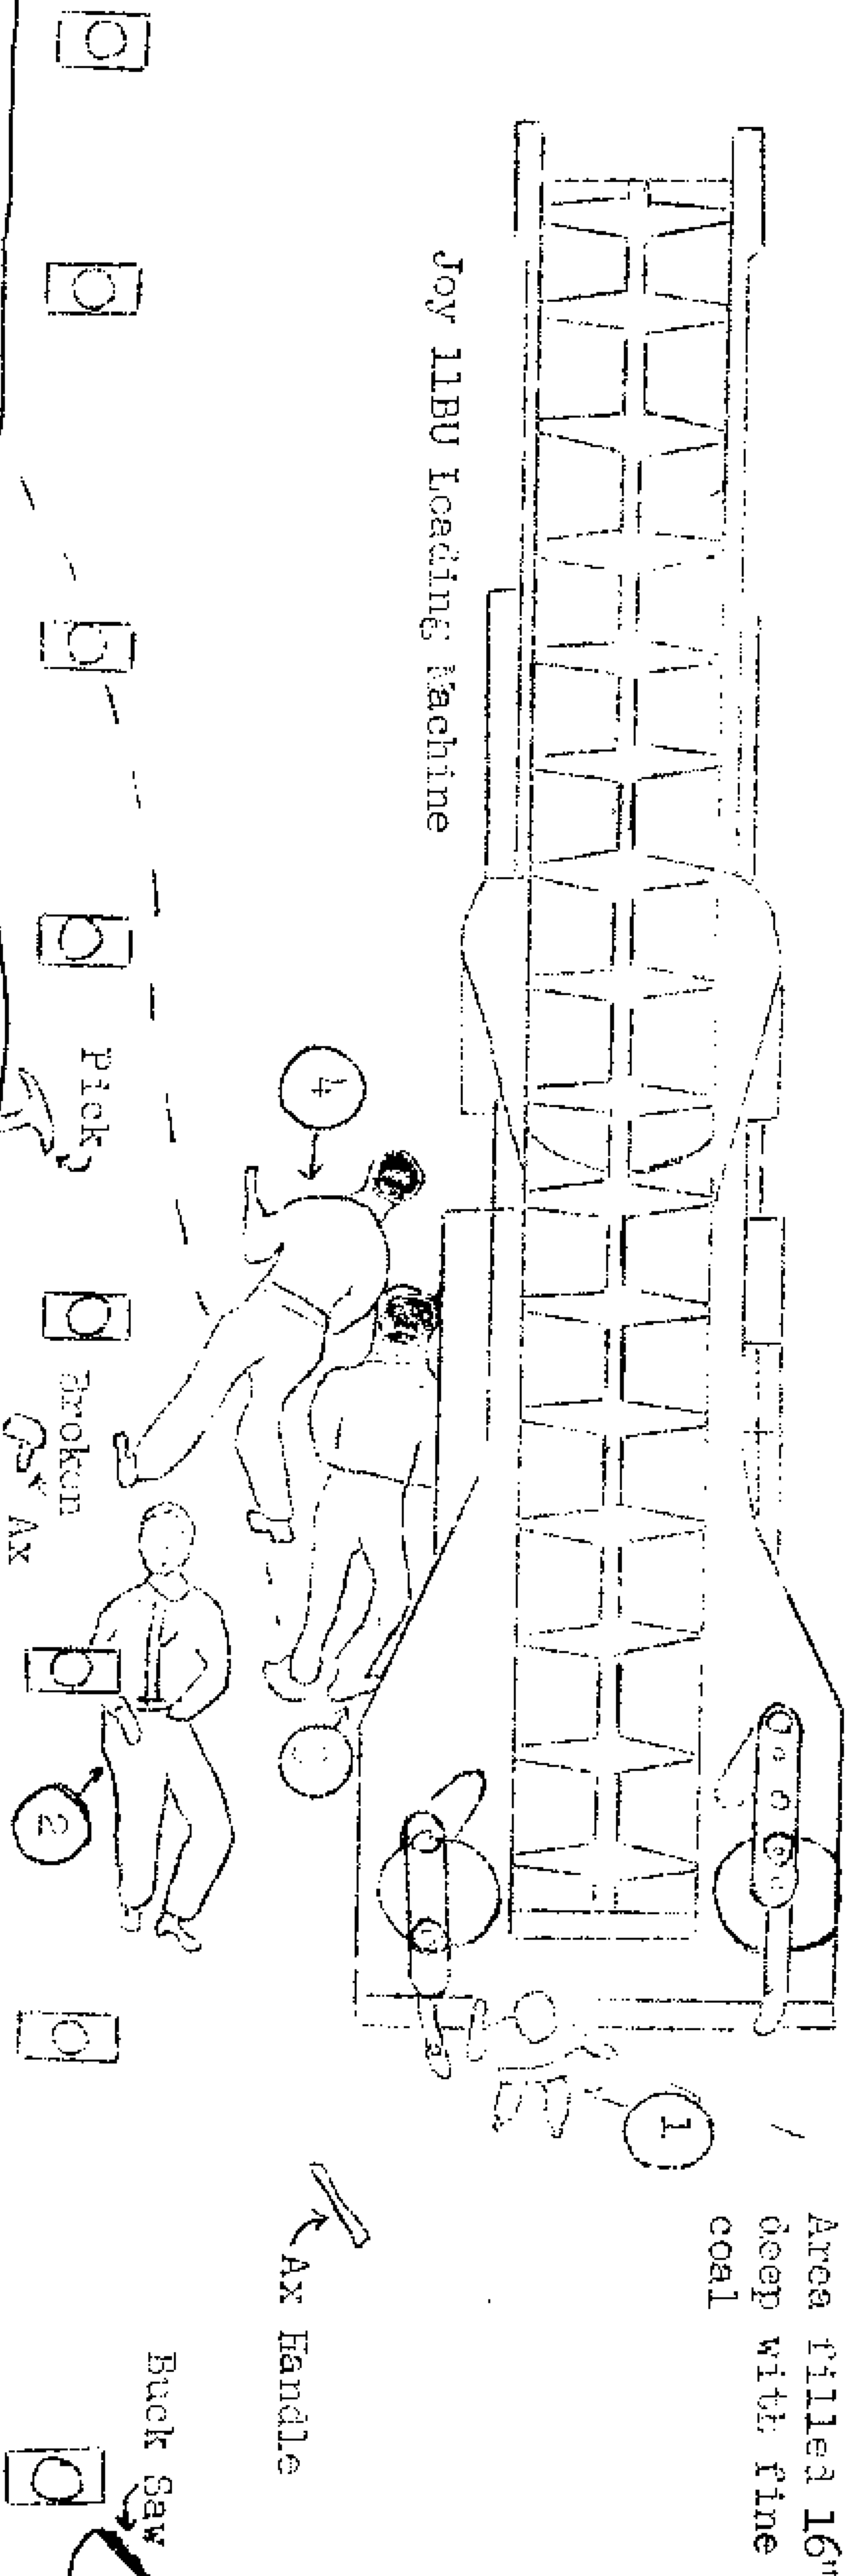
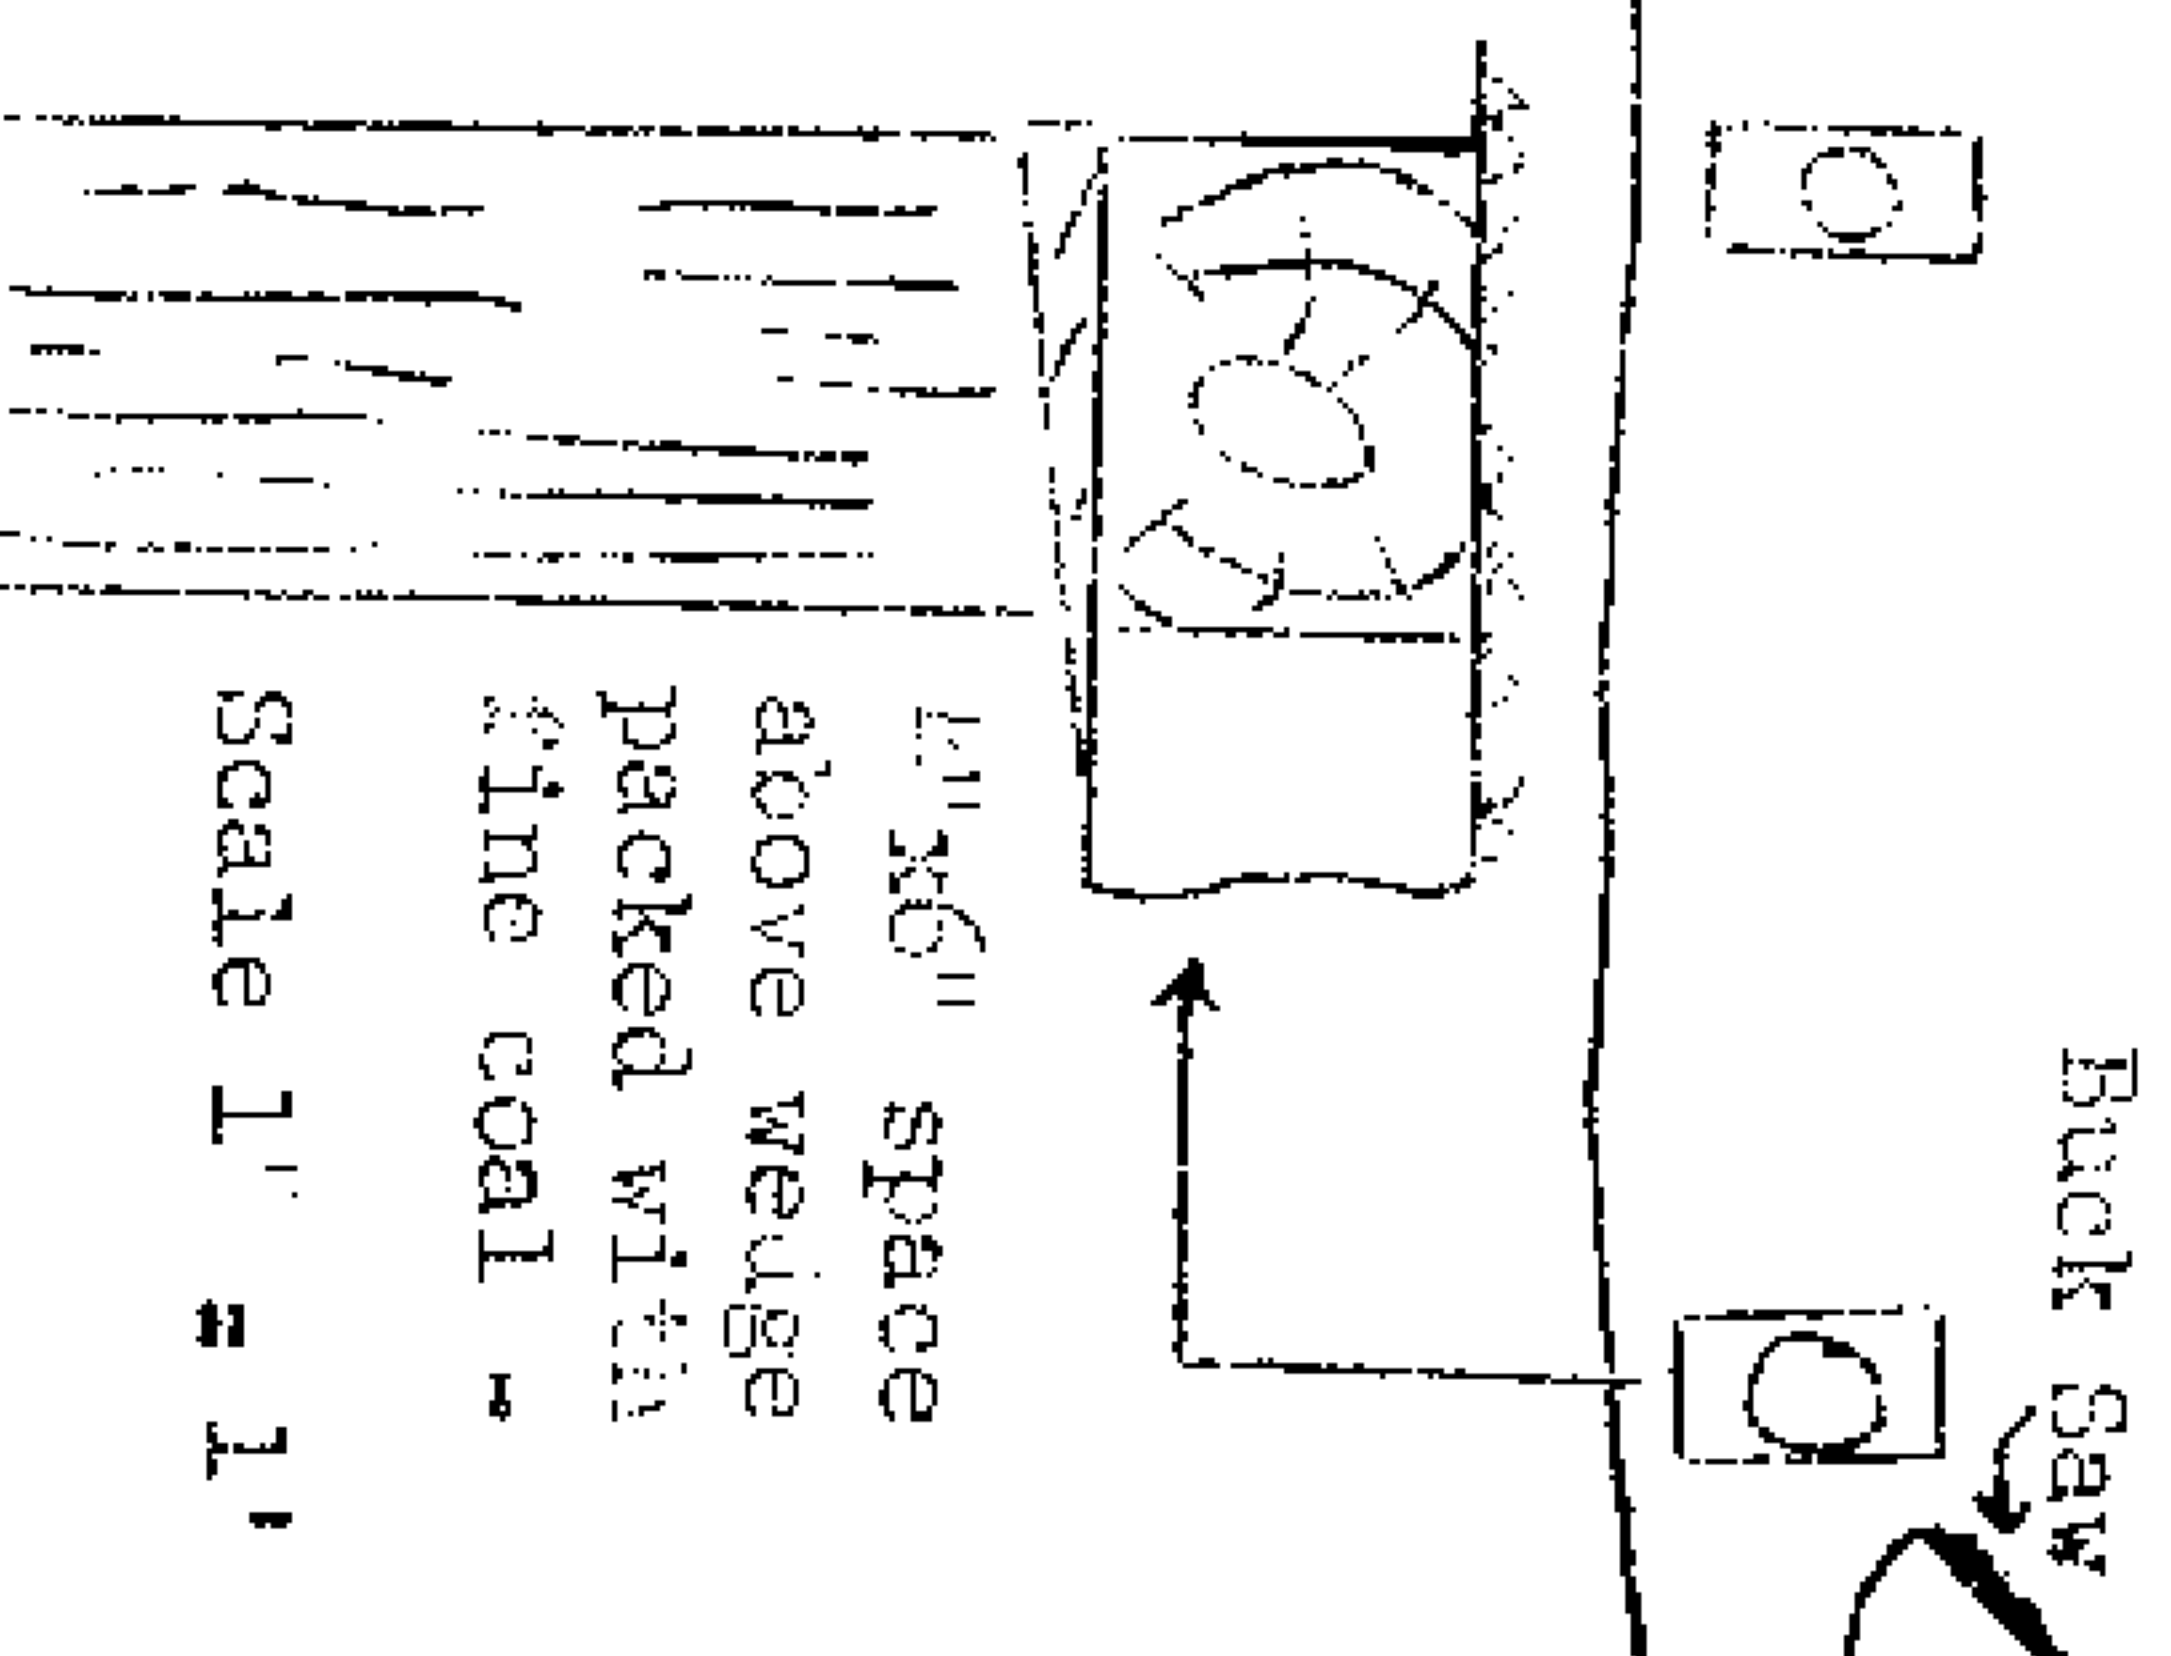
SKETCH NO. 2

- 1 - Assistant Mine Foreman
- 2 - Timberman
- 3 - Loading Machine Operator
- 4 - Loading Machine Operator's Helper

2" x 6" space above wedge packed with fine coal

6'6" of burlap cloth blown down from
1" x 6" supporting top board by force
of wind

23' deep
auger hole
filled with
coal
